Manhole Inspection Summary

Manhole # S02WW1010MH

Insp Date: **9/20/06 11:47 AM**

Location Address: **3702 W STRATHMORE AVE** Cross Street: **BILTMORE AVE**

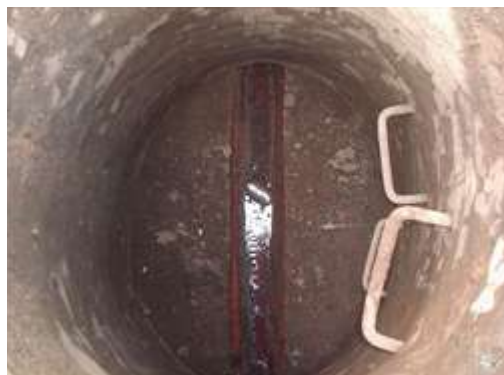
Top View

Comments **Top View picture indicates eviudence of infiltration through the Adjustment, Corbel, and the Barrel.**

Chimney / Frame Adjustment ☒ Exists Material: **Brick** ☐ Parged Height: **3** (in.)
Condition: ☒ Sound ☐ Cracked ☐ Root Intrusion ☐ Loose Brick ☐ Deteriorated
Infiltration: ☐ None ☒ **Joint** ☐ Cracks ☒ **Mortar** ☐ Roots ☒ **Wall**

Corbel Material: **Brick** ☐ Parged Type: **Concentric/Eccentric**
Condition: ☒ Sound ☐ Cracked ☐ Root Intrusion ☐ Loose Brick ☐ Deteriorated
Infiltration: ☐ None ☐ Joint ☐ Cracks ☒ **Mortar** ☐ Roots ☒ **Wall**

Barrel Material: **Brick** ☐ Parged
Shape: **Circular** Diameter: **46** (in.) Length: (in.)
Condition: ☒ Sound ☐ Cracked ☐ Root Intrusion ☐ Loose Brick ☐ Deteriorated
Infiltration: ☐ None ☐ Joint ☐ Cracks ☒ **Mortar** ☐ Roots ☒ **Wall**

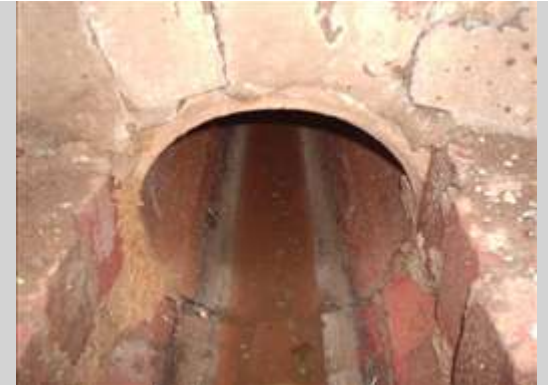
8 in. Circular Gravity Sewer Pipe Out @ 12 O'Clock

Pipe Material: **Clay** ☐ Pipe Lined

Invert Depth: **7.54** (ft.) Flow Characteristics: **Slow**

Deposits: ☒ None ☐ Mud ☐ Sludge ☐ **Debris** ☐ Grease

Infiltration: **Evidence** Pipe Seal Cond: **Cracked**

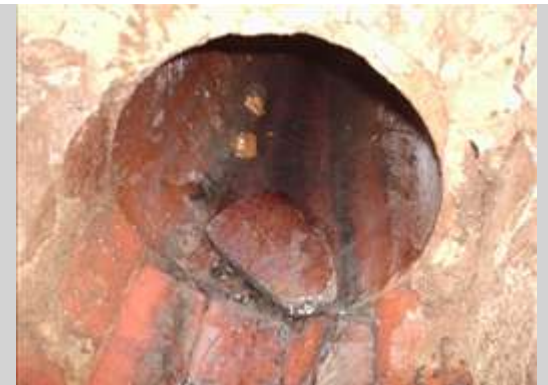
8 in. Circular Gravity Sewer Pipe In @ 6 O'Clock

Pipe Material: **Clay** ☐ Pipe Lined

Invert Depth: **7.53** (ft.) Flow Characteristics: **Slow**

Deposits: ☐ None ☐ Mud ☐ Sludge ☒ **Debris** ☐ Grease

Silt Depth: **0** (in.) Deposits Extent: **Light**

Infiltration: **Evidence** Pipe Seal Cond: **Cracked**
